# Technical Bulletin

Model(s)	Year	Eng. Code	Trans. Code	VIN Range From	VIN Range To
Jetta	2005 – 2010	All	All	All	All

55 14 04 December 4, 2014 2038992

### Corrosion on the Rear Lid around License Plate Lights

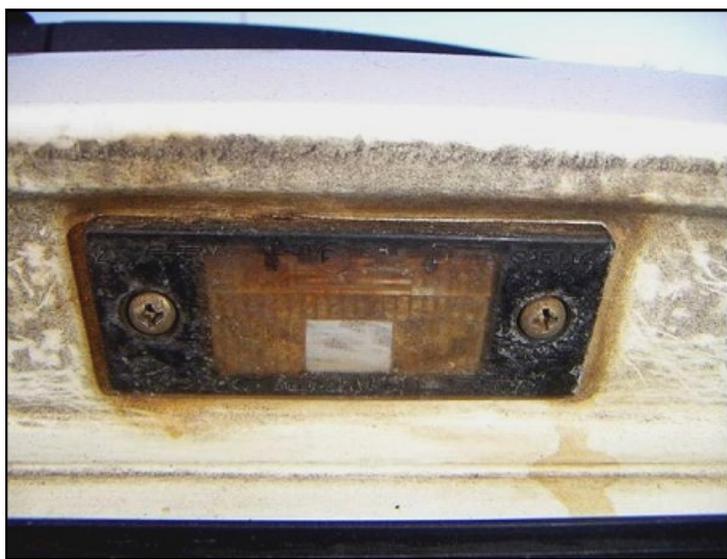
Figure 1: Corrosion on and around the license plate light

Electrolytic corrosion around the license plate lights (opening/contact surface, inside and outside) because of water ingress via the seal of the license plate lights.

#### 1a. Repair (Remove corrosion and restore paint structure).

#### 1b. Replace the rear lid.

- Remove the license plate lights from the rear lid according to the repair manual. See Repair Group 94 in Elsa.
- Remove all trim panels from the rear lid to prepare for corrosion removal according to the repair manual. See Repair Group 70 in Elsa.
- Remove the corrosion on the rear lid contact surface around the license plate light (inside and outside) with a pneumatic brush grinder.

- Prepare the rear lid for painting according to manufactures guidelines - it is not necessary to remove the glass.
- Apply a VOC compliant epoxy primer as an anti-corrosion treatment and primer (locally sourced).
- Repaint the rear lid according to manufactures guidelines.

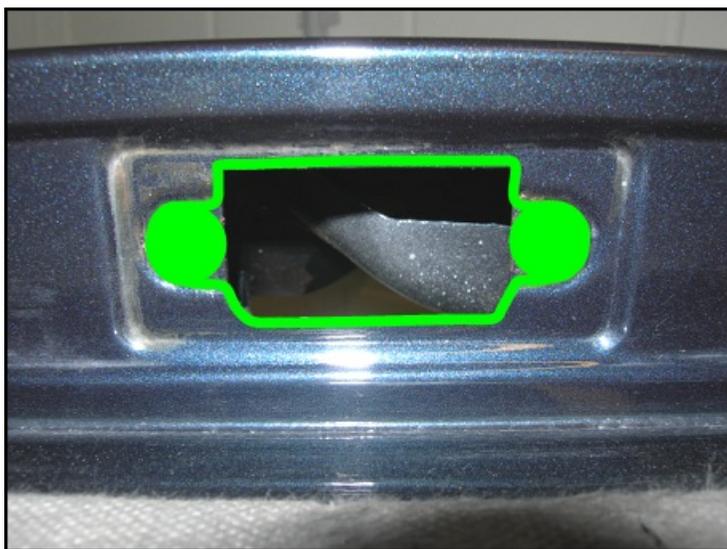
Figure 2) License plate light, butyl sealing cord areas

## 2. Additionally seal the contact surface of the license plate lights with butyl sealing cord (part number: AKL 450 005 05).

- Apply butyl sealing cord (0.2 cm x 20 cm) on the contact surface and attachment area of the license plate lights (Figure 2 and 3 in green).

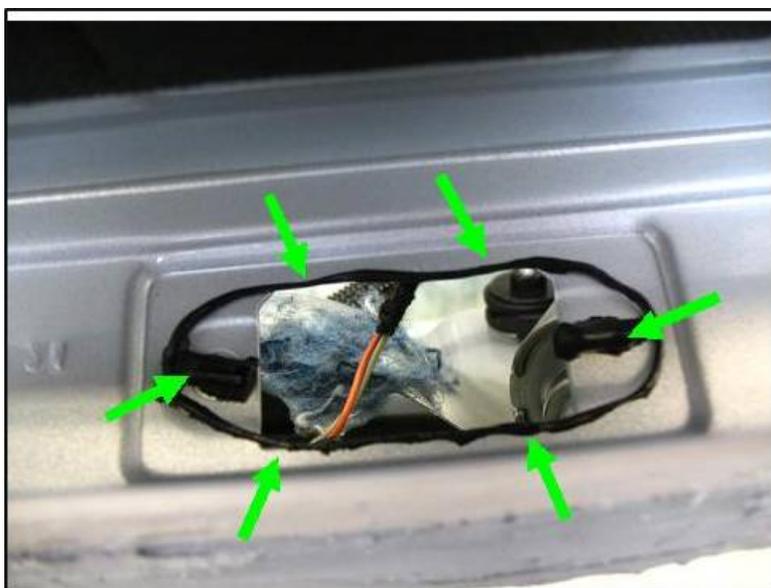
Figure 3) License plate light, contact surface and hole sealed with butyl sealing cord
